# Manhole Inspection Summary

Manhole # S33S\_\_011MH

Insp Date: **8/15/08 8:13 AM**

**Location** Address: **175 w ostend st**

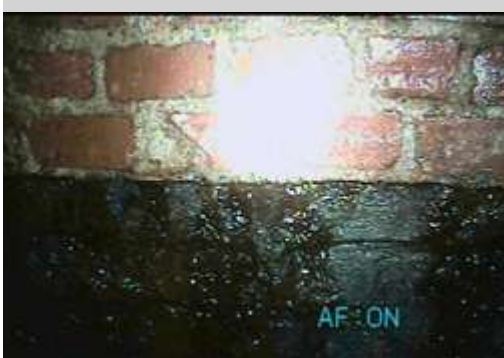
Defect 4

Infiltration: ☐ None ☐ Joint ☐ Cracks ☐ Mortar ☐ Roots ☒ **Wall**

infiltration in barrel wall

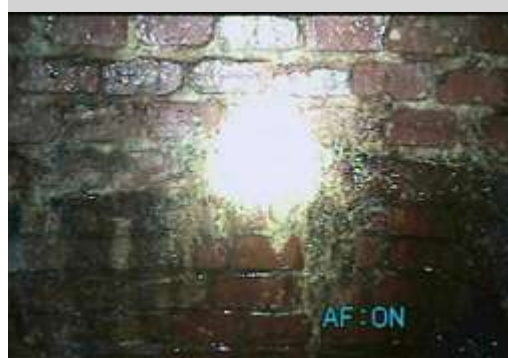
Defect 3

Infiltration: ☐ None ☐ Joint ☐ Cracks ☐ Mortar ☐ Roots ☒ **Wall**

infiltration in corbel

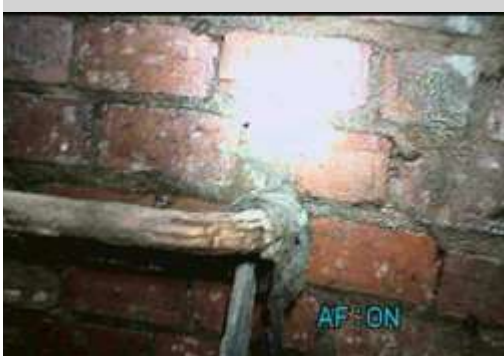
Defect 2

☒ **Evidence Of Surcharge** Depth: **9.** (ft.) ☐ Active Surcharge Present

evidence of surcharge

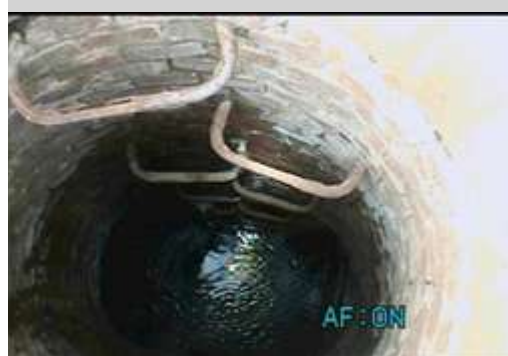
Defect 5

Count: **8** Missing: **0** ☒ **Corroded**

steps

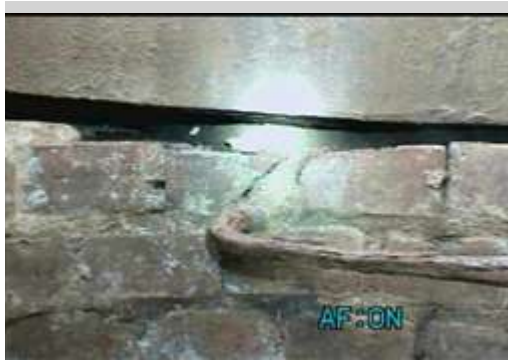
### Defect 1

Condition: ☐ Sound ☐ Cracked ☐ Root Intrusion ☐ Loose Brick ☒ **Deteriorated**

deteriorated chimney

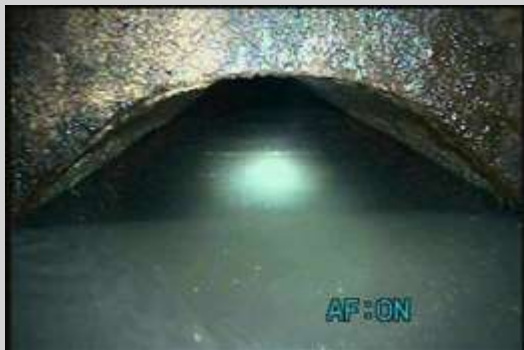
12 O'Clock Outflow

33 in. Circular Gravity Sewer  
Pipe Out @ 12 O'Clock

Invert Depth: **13.10** (ft.) Flow Characteristics: **Fast**

Infiltration: **None** Pipe Seal Cond: **Unknown**

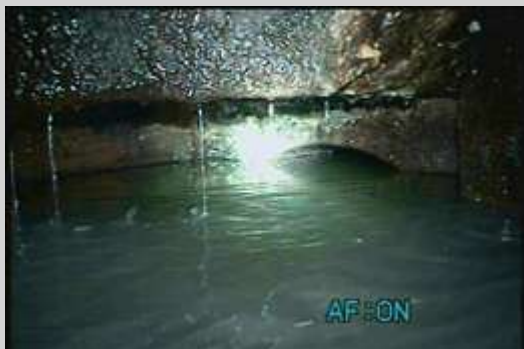
5 O'Clock Inflow

24 in. Circular Gravity Sewer  
Pipe In @ 5 O'Clock

Invert Depth: **10.50** (ft.) Flow Characteristics: **Fast**

Infiltration: **None** Pipe Seal Cond: **Unknown**

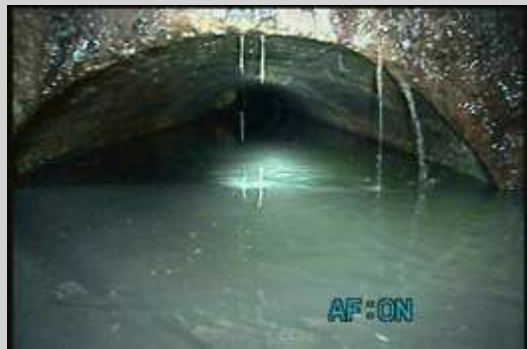
6 O'Clock Inflow

33 in. Circular Gravity Sewer  
Pipe In @ 6 O'Clock

Invert Depth: **12.88** (ft.) Flow Characteristics: **Fast**

Infiltration: **None** Pipe Seal Cond: **Unknown**
